Symptom

Affected Chassis:

Solution: recovered SW via One Button Reset (OBR).

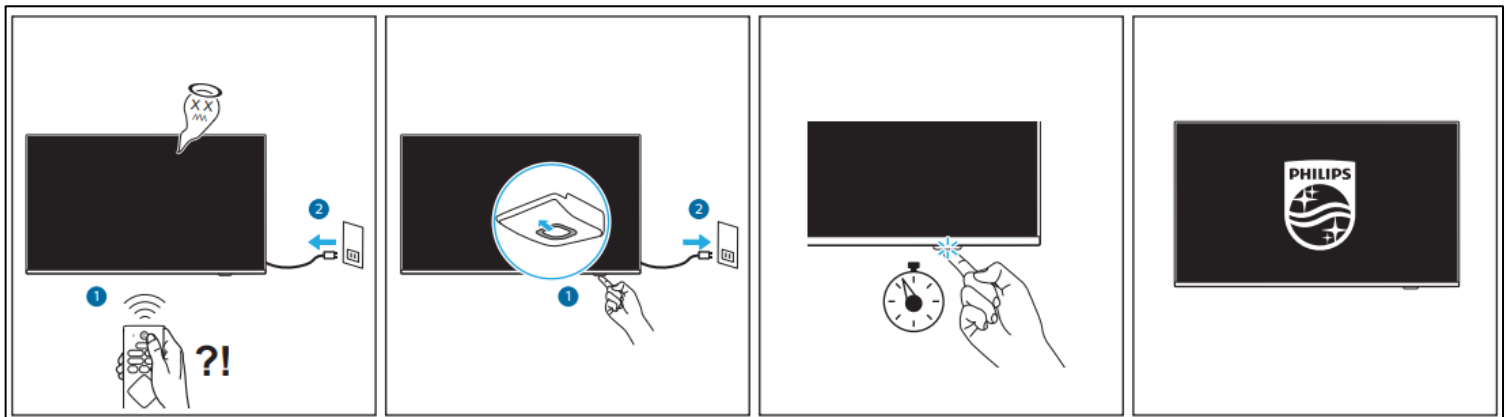
Figure 1. OBR mechanism.

TV sets with mentioned symptoms can be potentially recovered via the OBR as a potential substitute for having to flash the latest available SW again via PKG.

1. Power off the TV set by disconnecting it from mains.
2. Press the joystick to the DOWN position and hold it.
3. Power on the TV set while still holding the joystick in DOWN position.
4. Wait for the LED blink procedure to kick in (LED will blink in fast succession for a few seconds) or for the TV set to boot up.
5. Let go of the joystick.
6. The TV will now reboot and will trigger the virgin mode again.
7. The consumer can now install the TV from scratch and evaluate whether the issue is solved.
